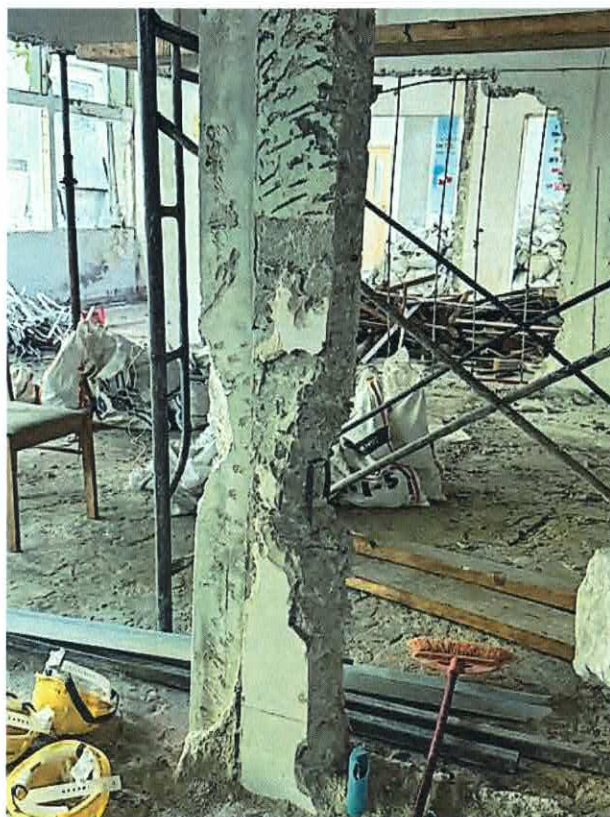
Figure 1. RC Column with spalling.

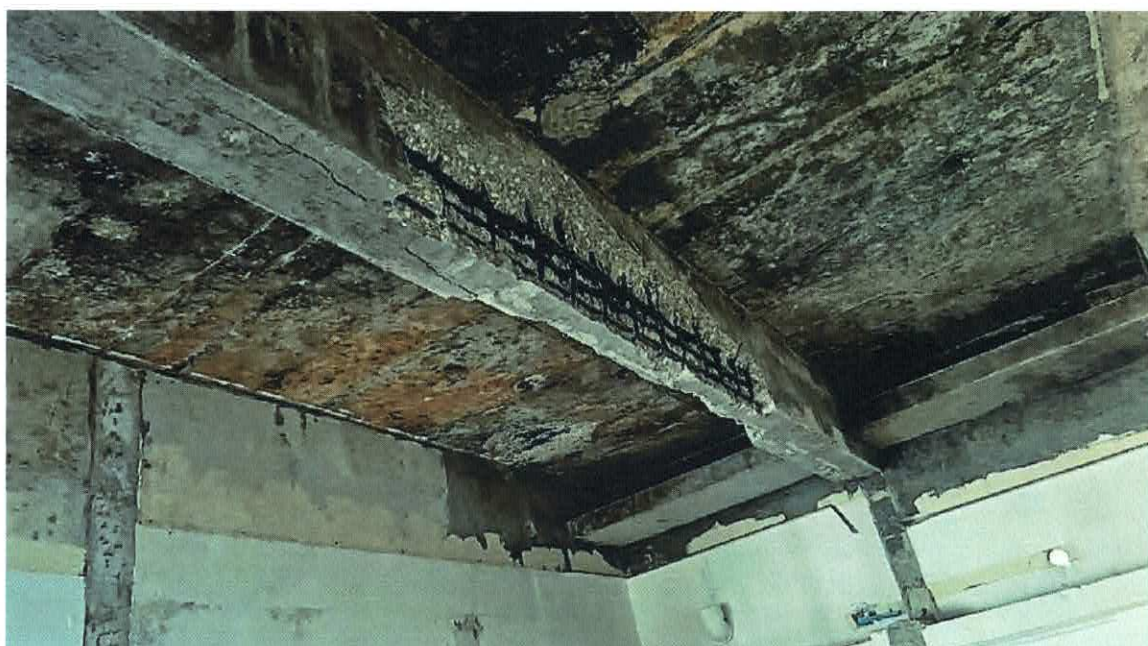
Figure 2 RC Beam with spalling damage, extensive up to 1.5m in length on long axis of beam, ground floor

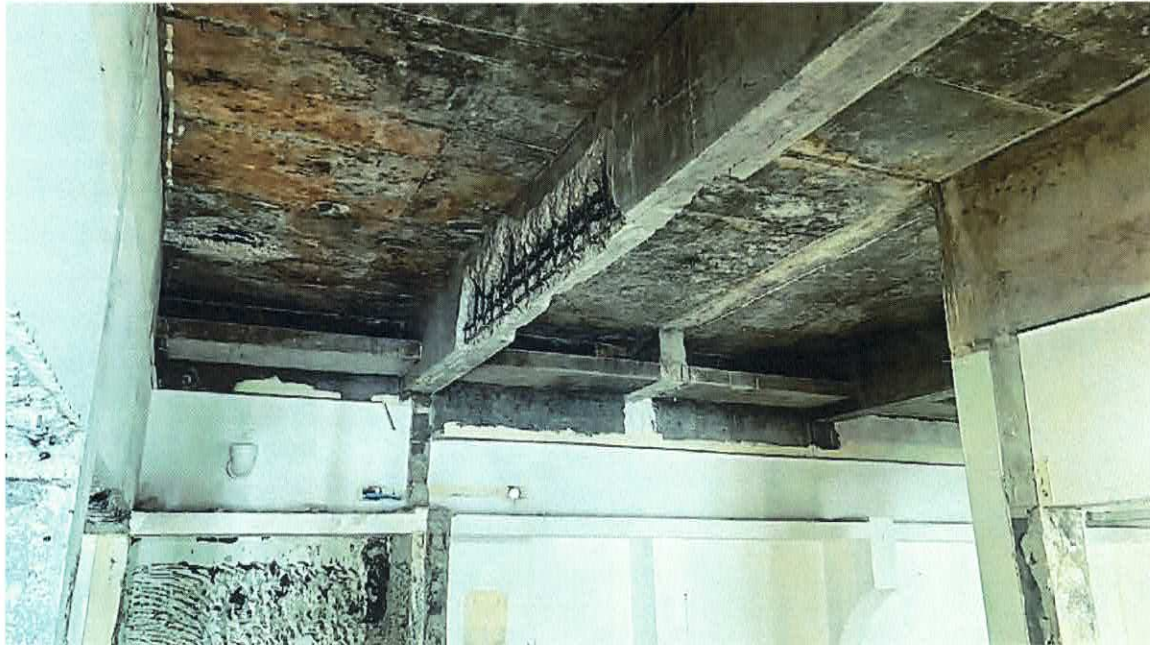
Figure 3 RC Beam showing extensive spalling, same as Figure 2 (opposing side).

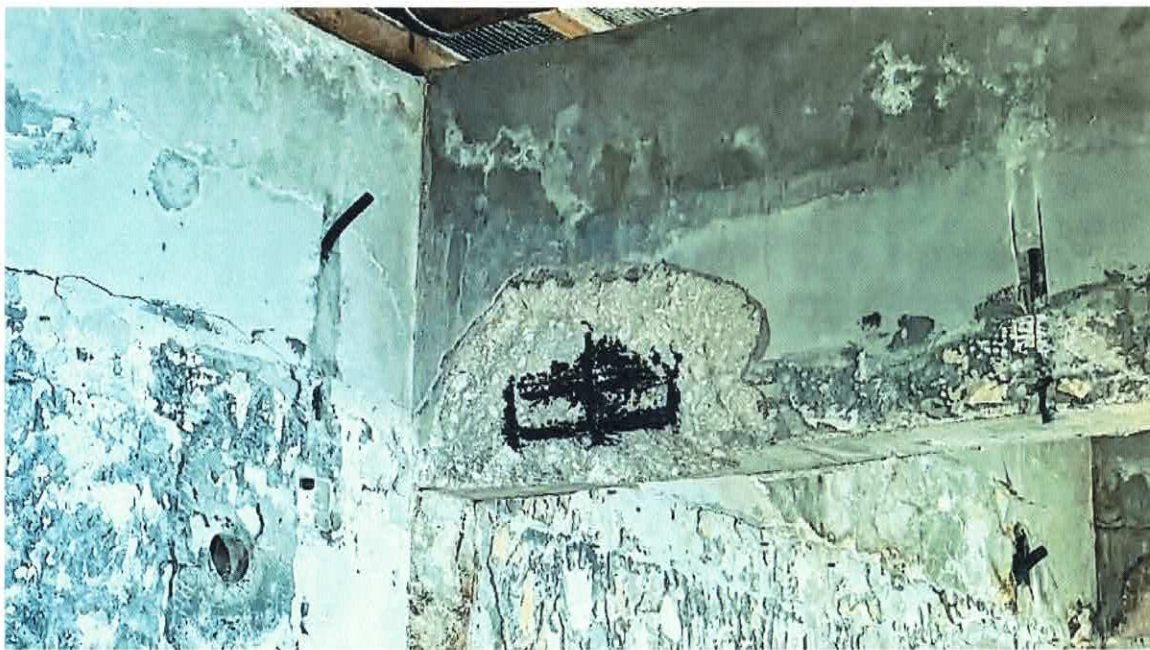
Figure 4 RC Beam, spalling damage, 2<sup>nd</sup> floor

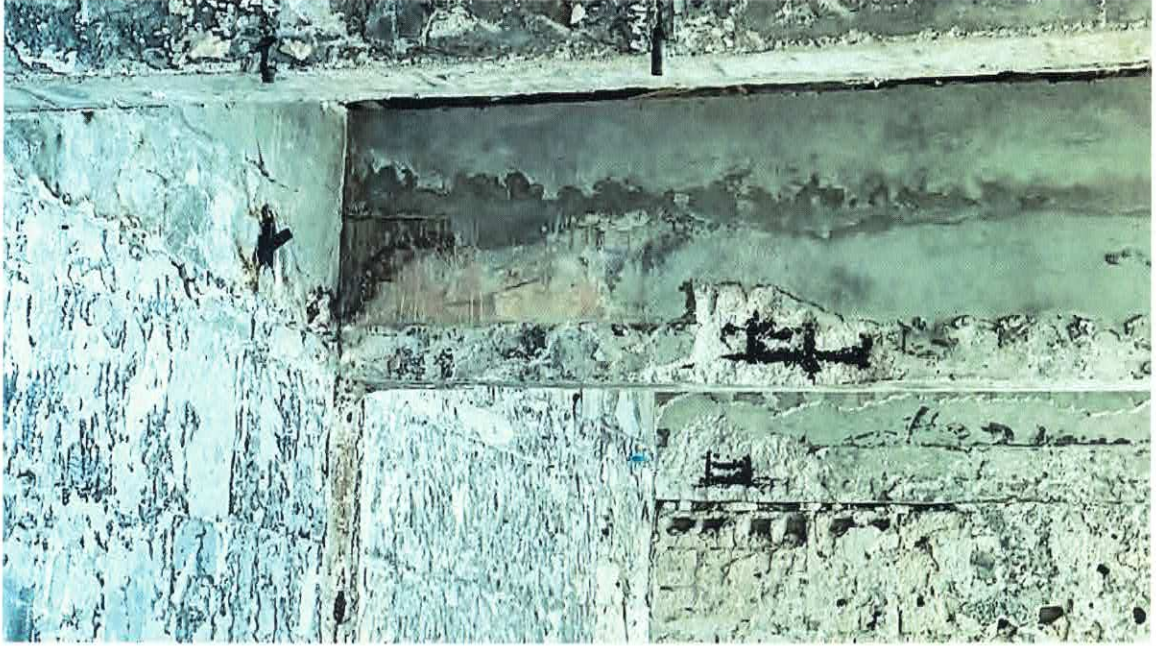
Figure 5 RC Beam spalling damages, 2nd floor

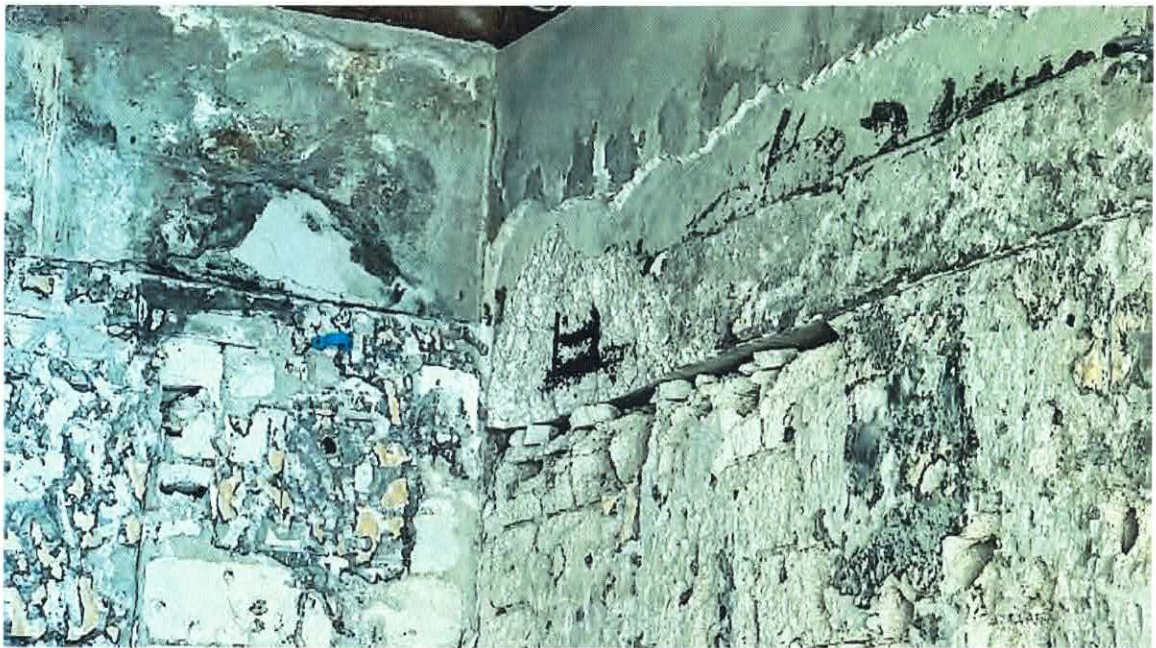
Figure 6 RC Beam spalling damage, 2nd floor

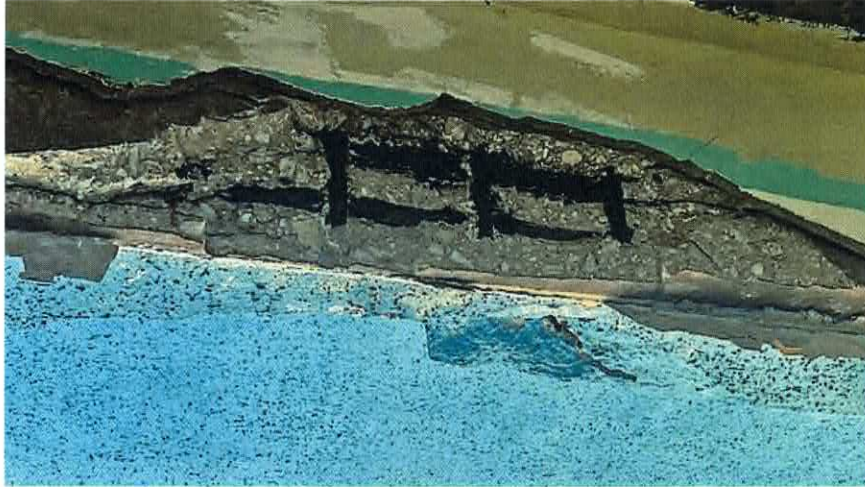
Figure 7 RC Beam spalling damage, 1st floor

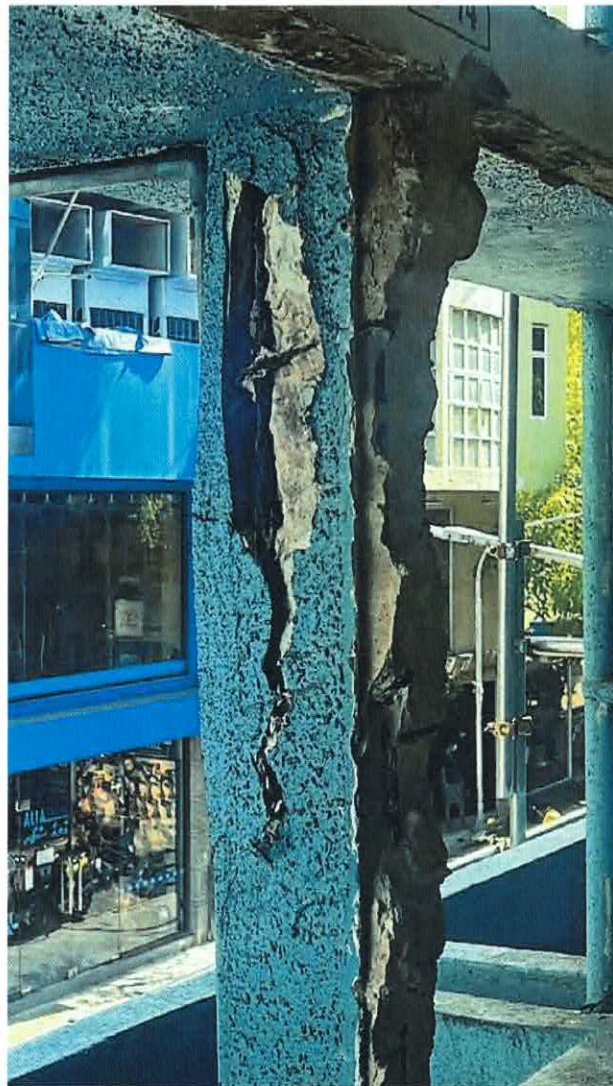
Figure 8 RC Column spalling damage, 1st floor

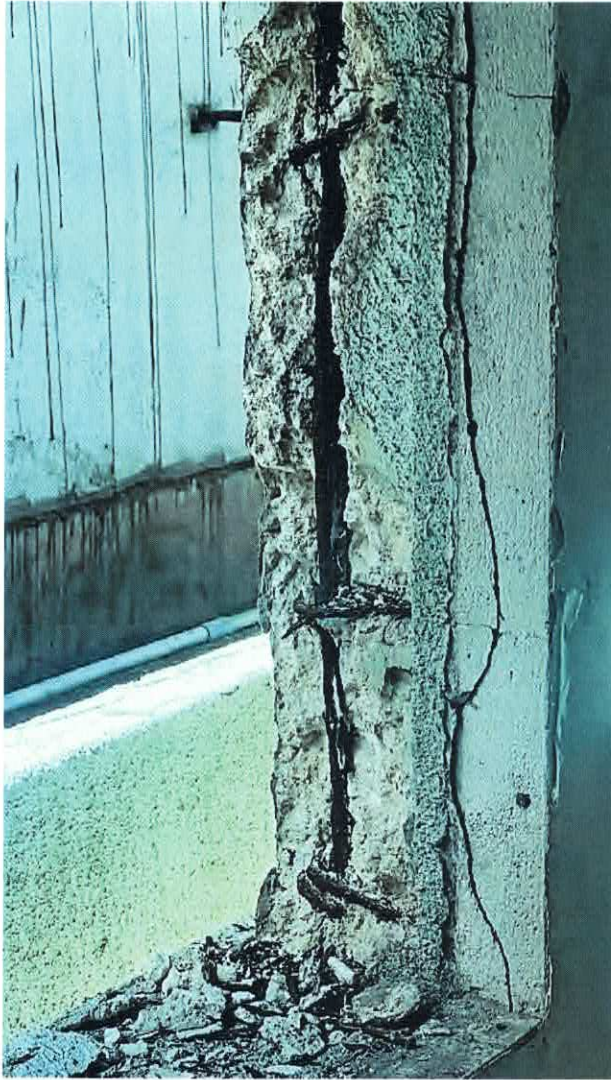
Figure 9 RC Column Spalling damage, ground floor.

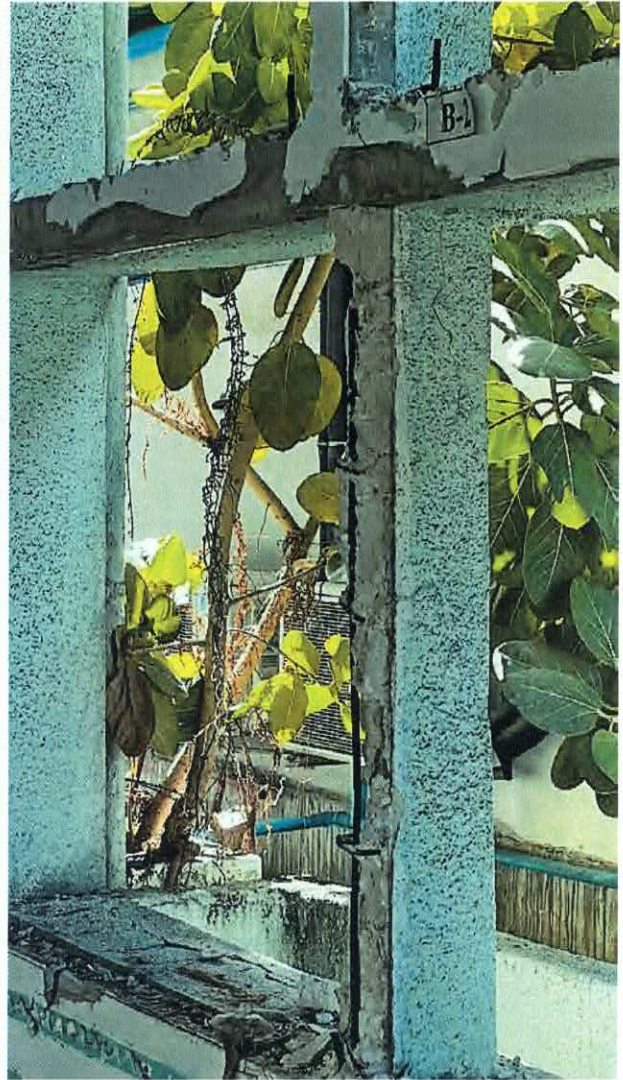
Figure 10 RC Column, spalling damage

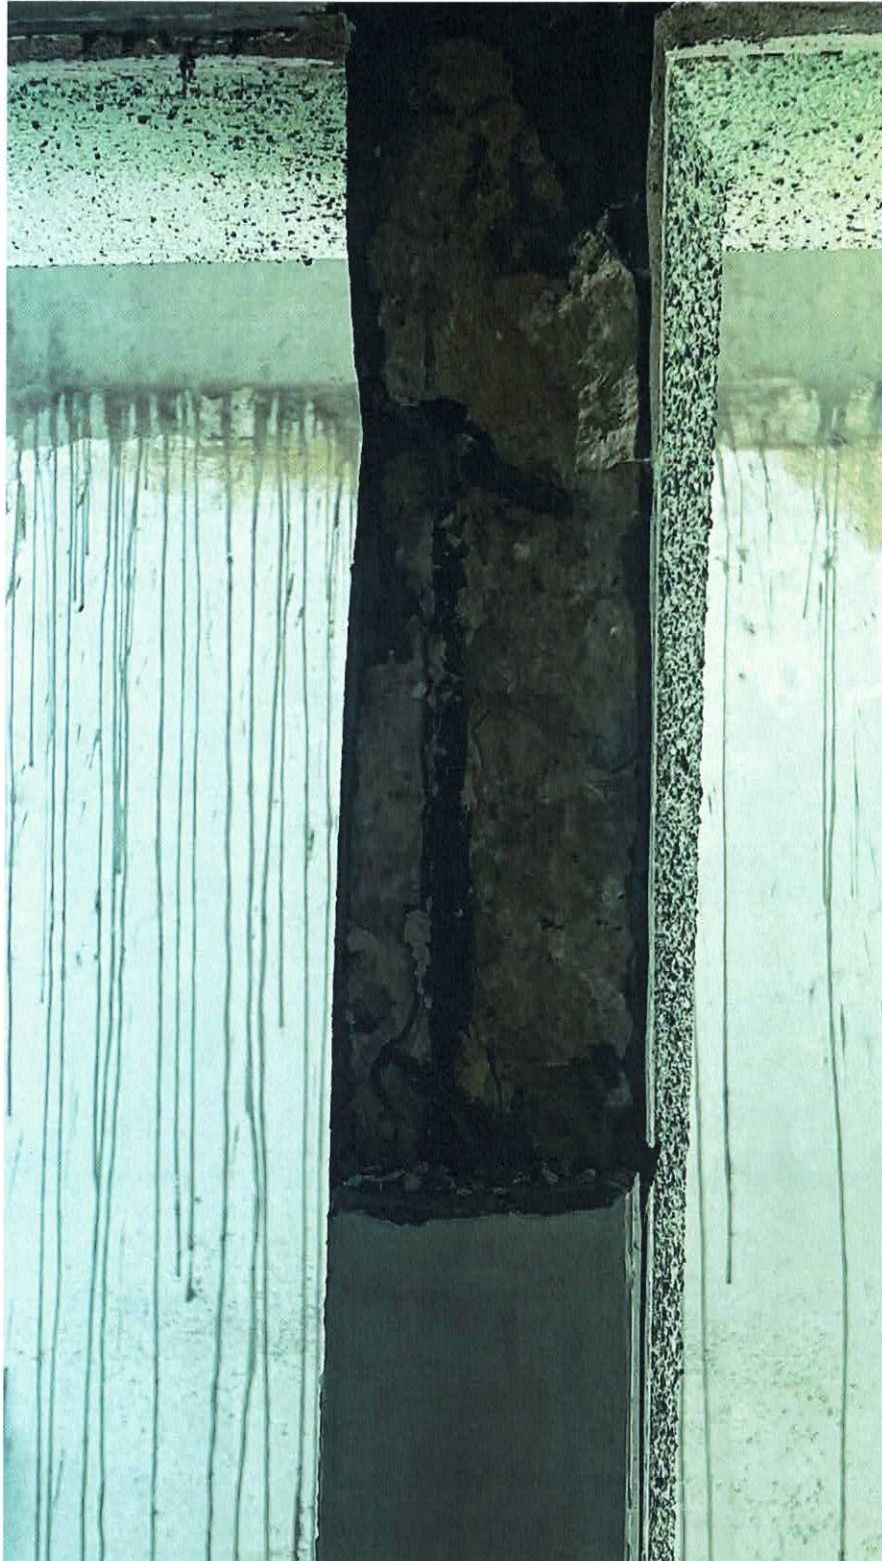
Figure 11 RC Column spalling damage

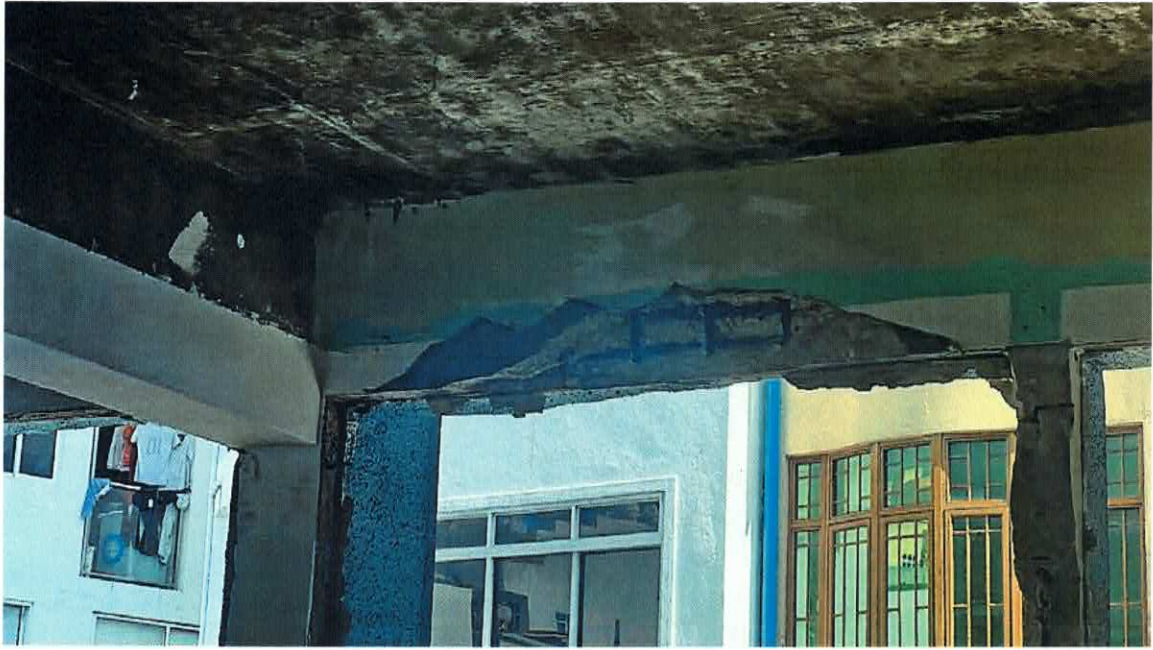
Figure 12 RC Beam, spalling damage, ground floor

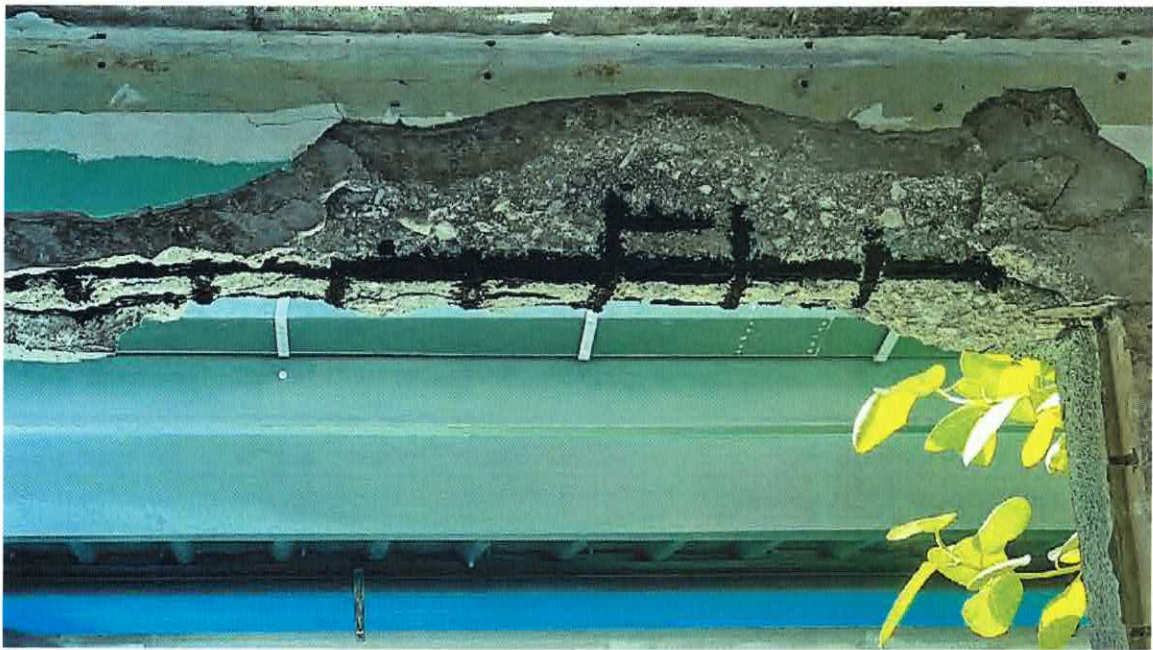
Figure 13 RC Beam, spalling damage.

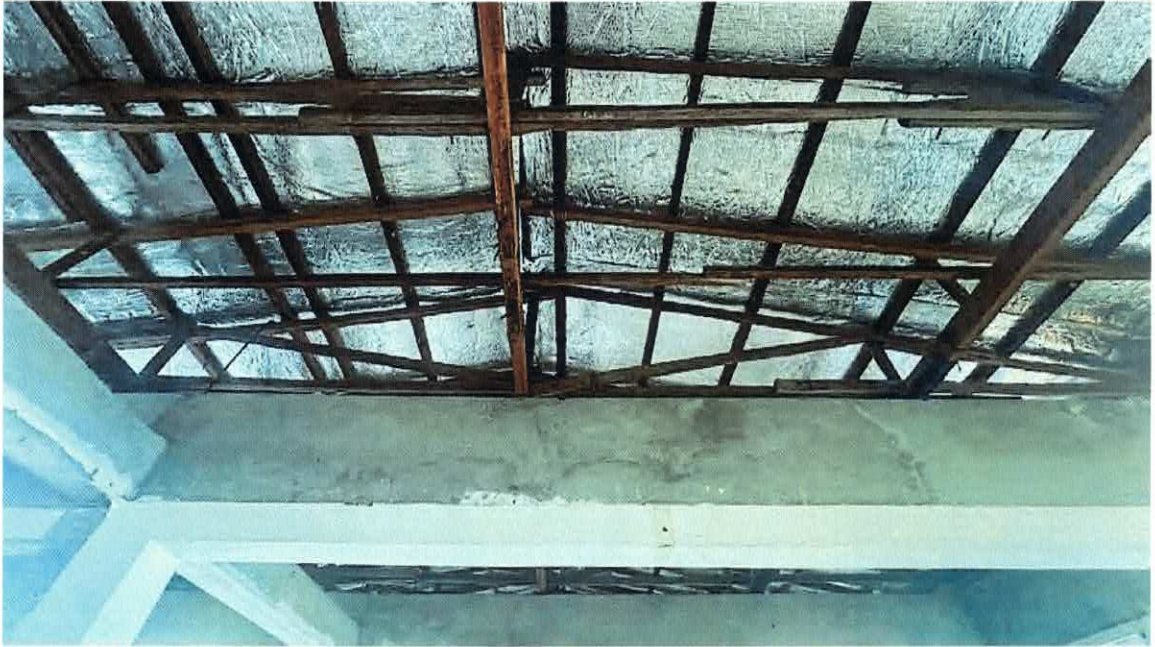
Figure 18 No major defects seen in roof structure

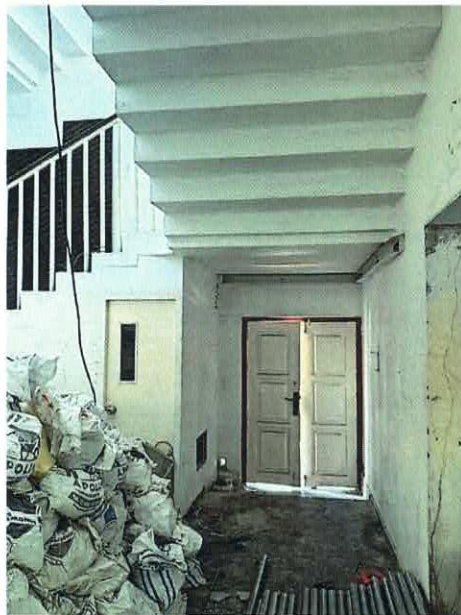
Figure 19 No defects seen in stair structures.
